## Visual Streambank Assessment

TOOKANY CREEK WATERSHED MANAGEMENT PLAN

Township of Cheltenham

Mill Run

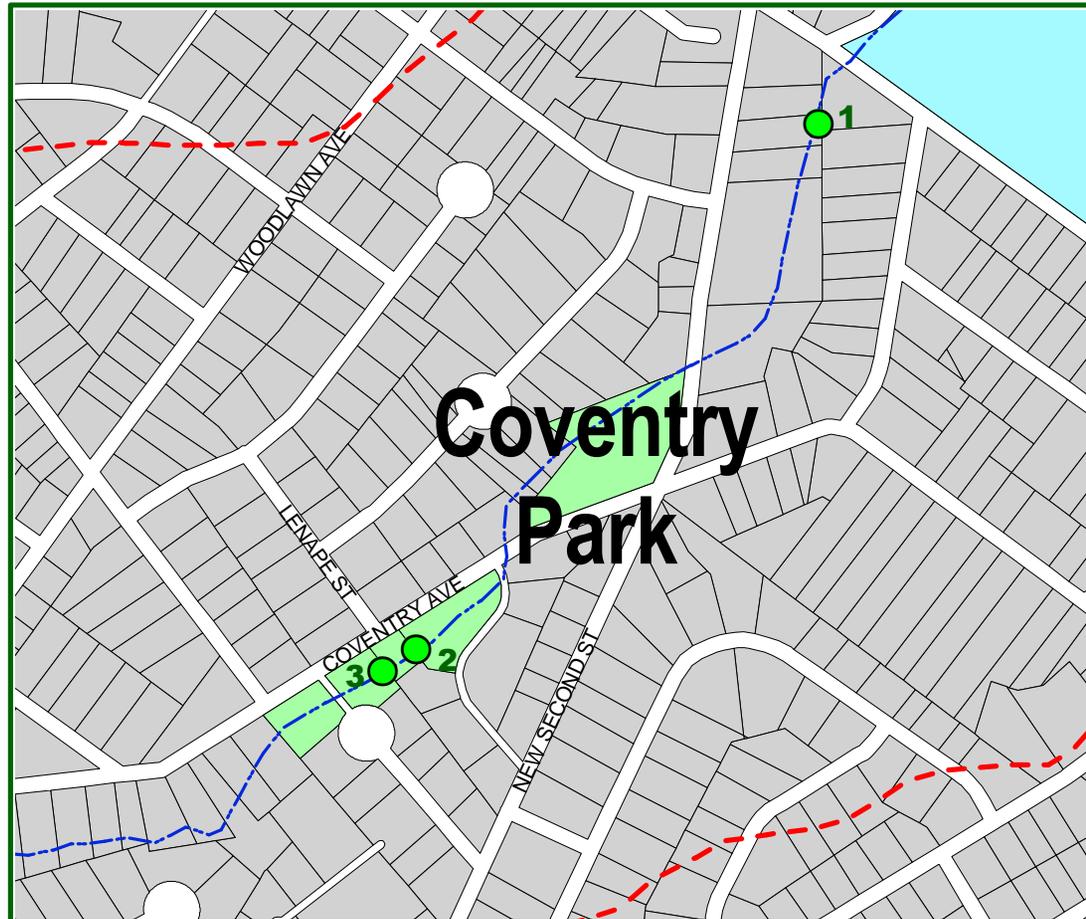
2 & 3. Stormwater has eroded away the top layer of soil under the wooded area near Lenape Street. This is further compounded by the slumping of the banks due to excessive volume of upstream stormwater.  
**Action/BMP** : Determine main area of excessive volume and velocity of stormwater and slow it down at its source through on-site infiltration. Develop infiltration trenches or swales parallel to the creek to intercept the stormwater.
